March 21, 2016

Re: Work Plan for Rock Placement on the Time Critical Removal Action
Armored Cap, San Jacinto River Waste Pits Superfund Site, Channelview, Texas

Table 1
Armored Cap Maintenance Locations
March 2016

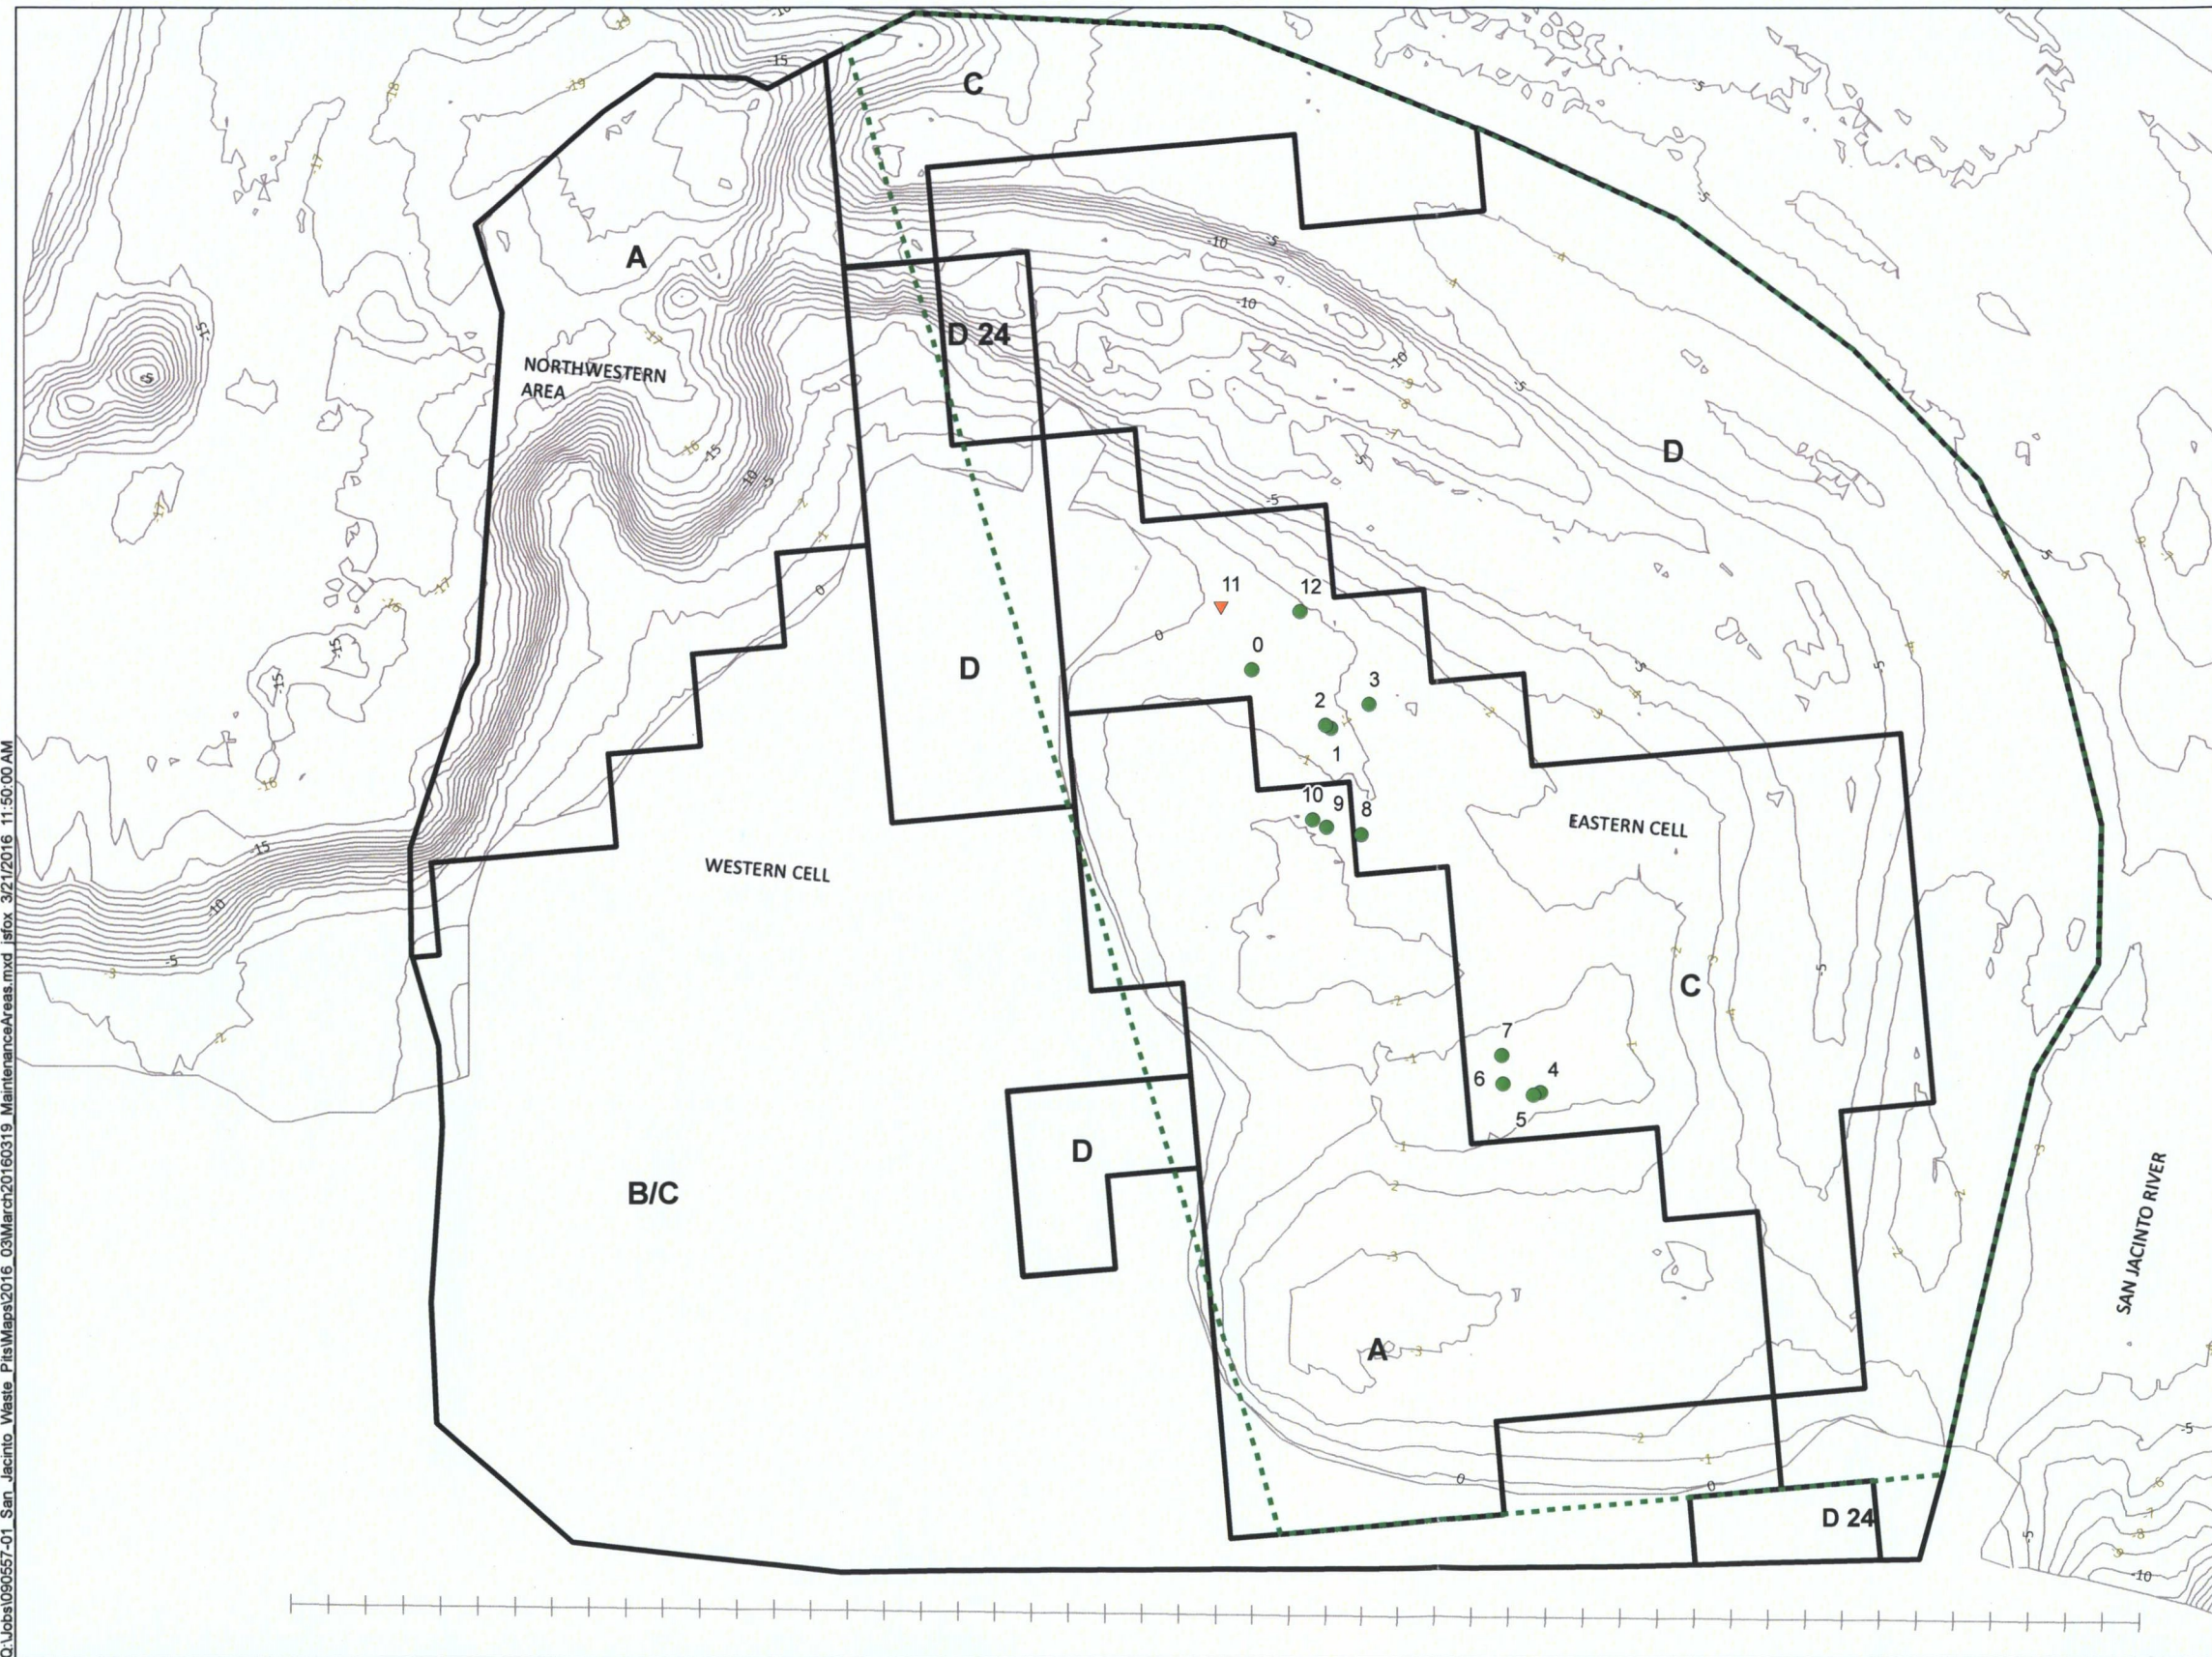
The results of the probing and visual inspection identified several discrete areas (e.g. 1' x 1') where geotextile was exposed, as summarized in Table 1 and shown on the attached Figure 1.

As you are aware, a skid steer front-end loader became disabled on the armored cap and the Respondents will place additional geotextile and armor rock in this area. In addition, the geotextile edge identified at Location 11 will also be addressed by placement of geotextile and armor rock.

Maintenance Location	Comment	X (UTM NAD83 - 15N)	Y (UTM NAD83 - 15N)	Maintenance Plan
0	Exposed Geotextile with rock beneath Indicative of Lap Joint	300665 5156	3297847 47	Add rock
1	Exposed Geotextile is 2x2 feet Some rock aggregate present Thin cap rock region is 2x6 feet	300672 5976	3297832 841	Add rock
2	Exposed geotextile 2x2 feet in area Some rock aggregate present	300672 013	3297833 713	Add rock
3	Exposed Geotextile 2x3 feet in area Some rock aggregate present	300680 1521	3297833 27	Add rock
4	Exposed Geotextile is 1x3 feet in area Some rock aggregate present	300675 29	3297763 589	Add rock
5	Exposed Geotextile is 1x1 feet in area Some rock aggregate present	300674 1382	3297763 769	Add rock
6	Exposed Geotextile is 1x1 feet in area Some rock aggregate present	300670 6068	3297767 763	Add rock
7	Exposed Geotextile is 1x1 feet in area Some rock aggregate present	300672 5902	3297771 977	Add rock

8	Exposed Geotextile is 2x1 feet in area Some rock aggregate present	300668 9628	3297815 019	Add rock
9	Exposed Geotextile is 1x1 feet in area Some rock aggregate present	300664 2992	3297818 844	Add rock
10	Exposed Geotextile is 2x2 feet in area Some rock aggregate present	300662 8045	3297821 023	Add rock
11	Exposed Geotextile, cause unknown Some rock aggregate present Possible joint	300665 6821	3297858 861	Add rock and geotextile
12	Centroid for area of exposed geotextile and thin cap rock Some rock aggregate present 20 square feet of area total	300676 9607	3297852 277	Add rock

Armor rock will be placed over each maintenance location shown on Figure 1 to assure that the design thickness of armor rock is present at all locations. As part of the Time Critical Removal Action planning for cap maintenance, two stockpiles of armor rock (armor rock C and armor rock D) were purchased and staged near the Site, and armor rock C will be used for this maintenance activity. Armor rock C is larger than or equivalent to the size of the

▲ Maintenance Point and ID - Add geotextile and rock

● Maintenance Point and ID - Add Rock
